# **Comprehensive Lake Management Plan**

## ***Big Chetac Lake***

Sawyer County, Wisconsin

SEH No. BIGCC 108473

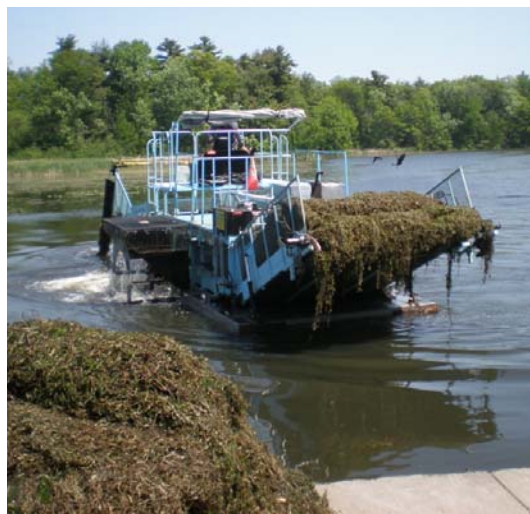
Mechanical removal of aquatic plants involves the use of motorized accessories to assist in vegetation removal. The most common form of this is the use of large-scale mechanical weed harvesters on the lake. Harvesting assumes that vegetation is cut and removed from the system after cutting. Harvesters are driven by modified paddle wheels and include a cutter that can be raised and lowered, a conveyor system to capture and store cut plants, and the ability to off-load the cut plants. The depth at which these harvesters cut generally ranges from skimming the surface to as much as five-feet deep. Harvesters can remove thousands of pounds of vegetation in a relatively short time period. They are not, however, species specific. Everything in the path of the harvester will be removed including the target species, other plants, macro-invertebrates, semi-aquatic vertebrates, forage fishes, young-of-the-year fishes, and even adult game fish found in the littoral zone (Booms, 1999). While relatively maneuverable in open water, the sheer size of the machines limits the area they can operate. They are most effective in larger lakes with ample littoral zone depth and where the target species is almost mono-typical.

While large-scale harvesting can remove large amounts of vegetation, re-cutting several times a season is often required to provide adequate annual control (Madsen, 2000). Large-scale plant harvesting in a lake is similar to mowing the lawn. Plants are cut at a designated depth, but the root of the plant is often not disturbed. Cut plants will usually grow back after time, just like the lawn grass. Harvesters can be effective at removing large masses of floating vegetation including CLP near the end of its life cycle. When considering a large-scale harvesting operation, much consideration needs to be given to the timing of harvesting. CLP has a 2-4 week window where harvesting can be most effective. Removing plants when they have reached peak growing mass, yet not begun to produce turions, provides the most benefit for long-term relief.

Large-scale harvesting often leaves large amounts of floating fragmented vegetation to move about the lake and wash up onto shorelines. Removing washed in fragments from beaches and lake fronts can be an arduous task for riparian owners. Harvesting activities in shallow water can re-suspend bottom sediments into the water column releasing nutrients and other accumulated compounds (Madsen, 2000).

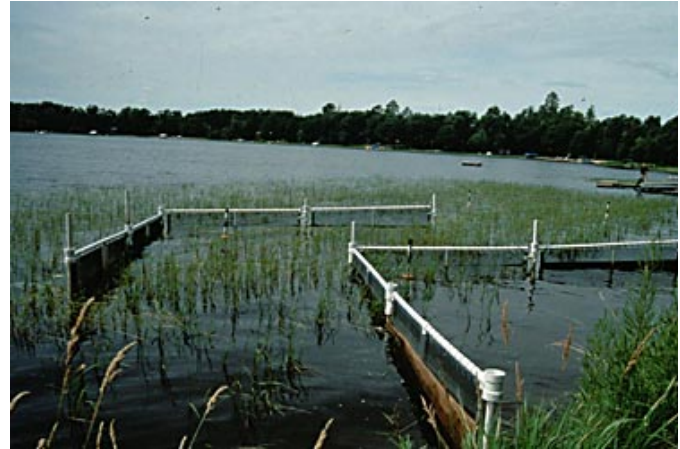
Langlade County, Wisconsin "Buffer Blocker" System
